3" Side Bar

Part No.1110122881/3

Fits: 1988-1998 Chevrolet/GMC C/K Pick Up Extended Cab (2-door cab only)

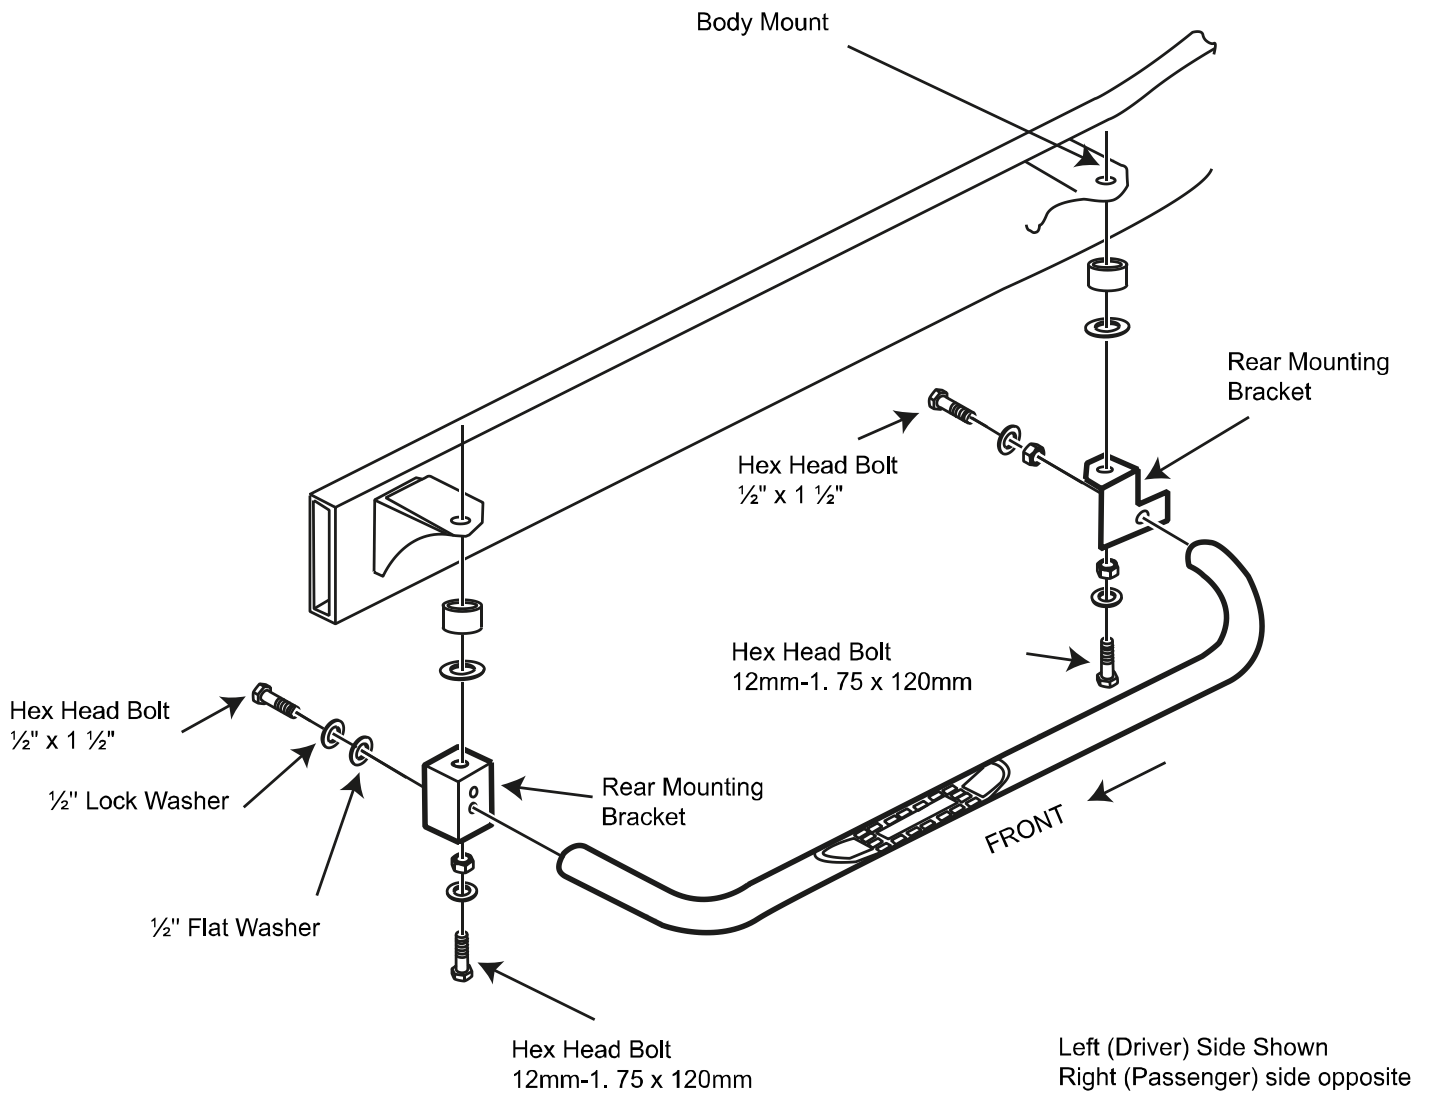
(Illustration 1)

DRIVER (LEFT) FRONT	DRIVER (LEFT) REAR	PASSENGER (RIGHT) REAR	PASSENGER (RIGHT) FRONT

1. Remove the end caps on the side bars before beginning installation.
2. Locate the correct Side Bar and set of Brackets referenced in the illustration. (See Illustration1).
3. **Bracket Installation:** Locate the existing bolts on the correct body mounts of the chassis. Remove them and install the brackets. Use the M12 x 1.75 x 120mm Hex Head Bolts with the Flat and Lock Washers. Do not tighten. (See Illustration1).
4. **Side Bar Installation:** Hold the side bar up to the brackets and install using the 1/2" x 1 1/2" Hex Head Bolts with the Flat and Lock Washers. (See Illustration1).
5. Tighten the body mount bolts. Then align the Side Bar and tighten the Side Bar bolts.
6. Recheck bolts periodically.

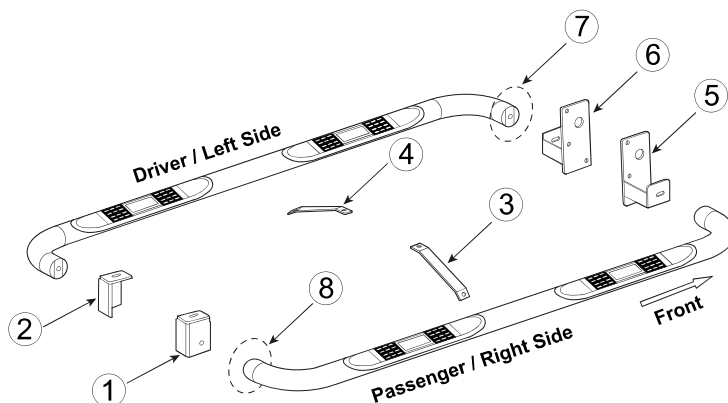
PARTS IDENTIFICATION GUIDE

Driver Side tube taped in "Red" Color. Passenger Side tube taped in "Blue" Color.

No.	Parts Identification
1	Passenger / Right 'Rear' Bracket marked "RR"
2	Driver / Left 'Rear' Bracket marked "RL"
3	Passenger / Right 'Center' Bracket marked "CR"
4	Driver / Left 'Center' Bracket marked "CL"
5	Passenger / Right 'Front' Bracket marked "FR"
6	Driver / Left 'Front' Bracket marked "FL"
7	'Left' marked "L"
8	'Right' marked "R"

In some cases Illustration images shown in Installation manual may not be the exactly same as per actual vehicle images ,also if Driver / Passenger side mounting brackets are very identical in the design, suggest referring Parts Identification guide to avoid fitment issue.

Side bar may be interchanged or mounting brackets are not installed at the correct position in the vehicle. Refer Parts identification guide.
