Replacement Rear Bumper

Part No. FX1010

Fits: 2014-2015

Nissan Titan

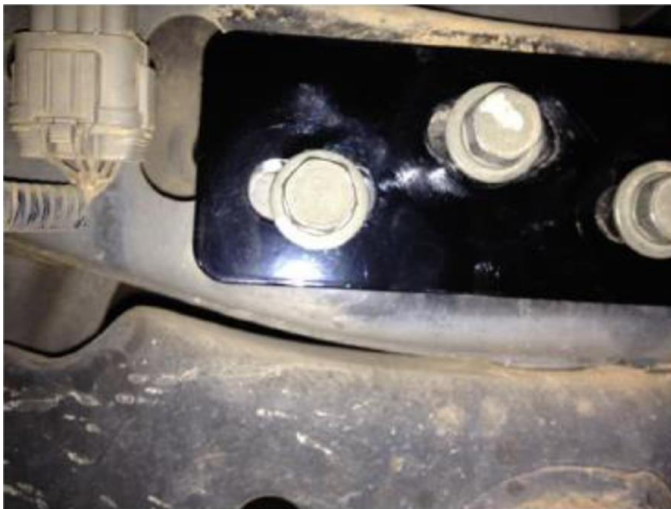
4. Secure all loose wiring and harnesses to the frame or bumper with zip ties.
5. Replace OEM bumper with the TFX rear bumper assembly. Use the factory hardware and the 17mm socket to attach to the frame. Do not fully tighten.
6. Level and align the bumper in relation to the truck bed. Fully tighten all fasteners.
7. Slowly lower the tailgate to ensure there will be no interference. If required, loosen the frame bolts / hitch bolts and adjust alignment of the bumper.
