# 3" Side Bar Part No. A0056S /T

Fits: 2018-Current WRANGLER JL 2DR

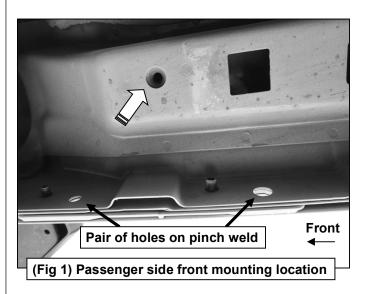
- **1.** Start installation toward the front of the passenger side of the vehicle and find the front threaded insert located in between the first pair of holes along the pinch weld, **(Figure 1)**.

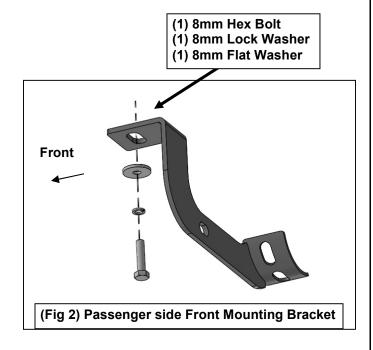
- 2. Select the Passenger side Front Mounting Bracket, (Figure 2). IMPORTANT: Use the illustration above to properly identify the Mounting Bracket. Attach the Bracket to the threaded insert using (1) 8mm Hex Bolt, (1) 8mm Lock Washer and (1) 8mm Flat Washer, (Figure 2). Do not tighten hardware at this time.

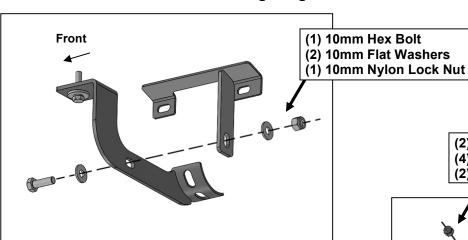
(Fig 3) Attach the Front Support Bracket to the <u>rear</u> side of the Front Mounting Bracket

- 3. Next, select the Passenger side Front Support Bracket, (Figure 3). IMPORTANT: Use the illustration above to help identify the correct Support Bracket. Use (1) 10mm Hex Bolt, (2) 10mm Flat Washers and (1) 10mm Nylon Lock Nut to attach the Support Bracket to the <u>rear</u> side of the Front Mounting Bracket, (Figure 3). Attach the Support Bracket to the <u>back</u> of the pinch weld using (2) 6mm Hex Bolts, (4) 6 mm Flat Washers and (2) 6mm Nylon Lock Nuts, (Figures 4 & 5). NOTE: Insert bolts from the outside of the pinch weld and through the Bracket. Do not tighten hardware at this time.

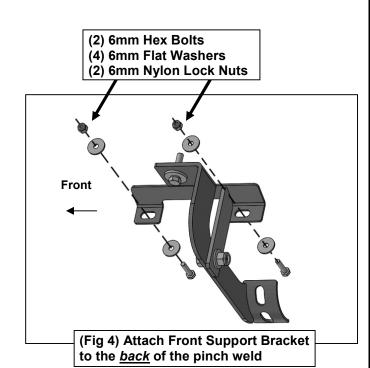
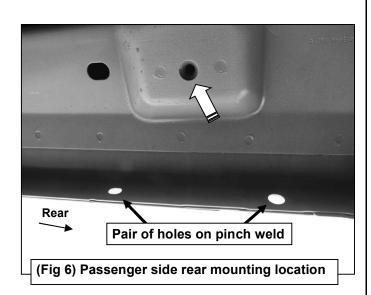
1 lg // Fassenger/light side from brackets installed

- **4.** Move to the rear mounting location and locate the threaded insert and pair of holes on the pinch weld, **(Figure 6)**. Repeat **Steps 3 & 4** to install the Rear Brackets, **(Figure 7)**.

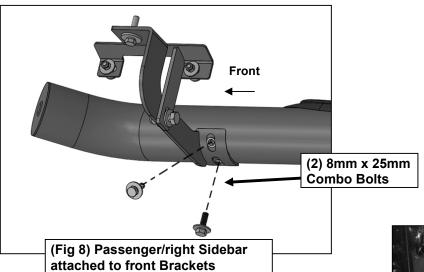
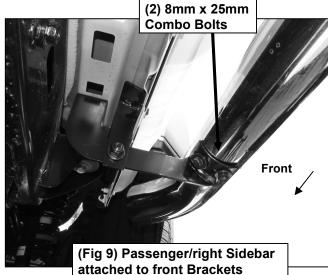
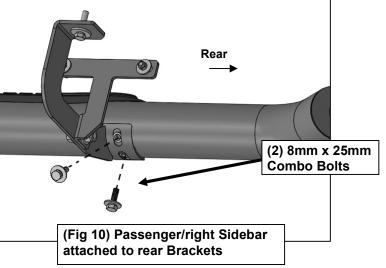
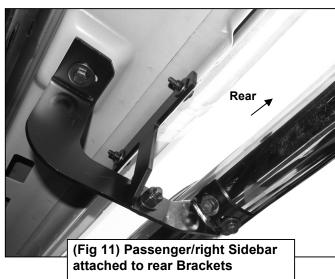
may result. Attach the Sidebar to the Mounting Brackets with (4) 8mm x 25mm Combination Hex Bolts, (Figures 8—10). Do not tighten hardware.
