Jeep Product Part No. J053T

Jeep Wrangler JL Fits: 2018-Current

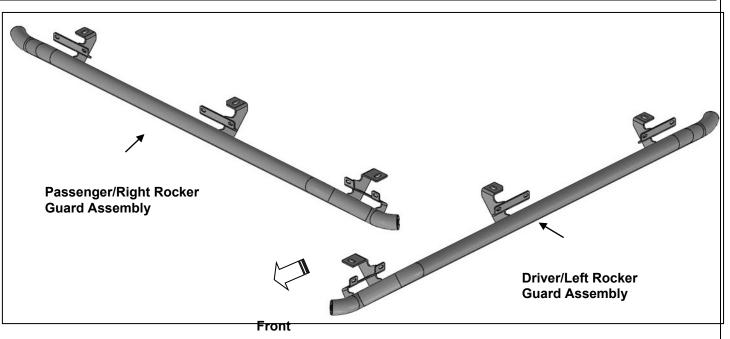
6mm Nylon Lock Nuts

8-1.25mm x 35mm Hex Bolts

8mm Lock Washers

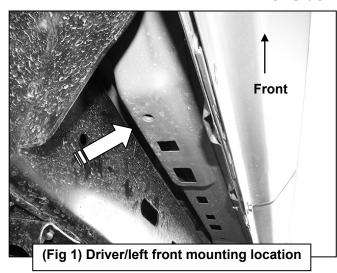
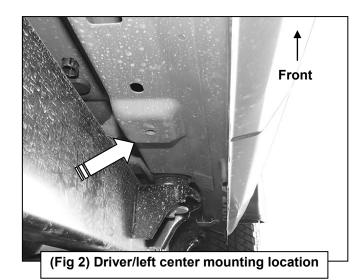
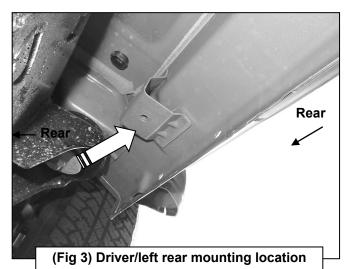
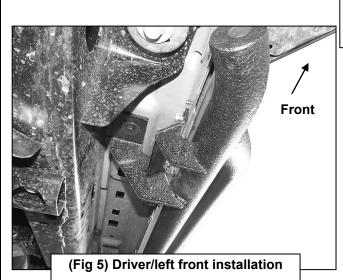
Driver Side Installation Pictured

(2) 6mm Hex Bolts (4) 6mm Flat Washers

(2) 6mm Nylon Lock Nuts

- 3. With assistance, attach the Rocker Guard to the <u>back</u> of the pinch weld using the included (6) 6mm x 25mm Hex Bolts, (12) 6mm Flat Washers and (6) 6mm Nylon Lock Nuts, (Figures 4—9). Leave hardware loose at this time.
- **4.** Attach the mounting tabs on the Rocker Guard to the (3) threaded holes in the floor with the included (3) 8mm x 35mm Hex Bolts, (3) 8mm Lock Washers and (3) 8mm Flat Washers, (Figures 4—9).
- **5.** Adjust the Rocker Guard and tighten all hardware.
- **6.** Repeat **Steps 2—5** for passenger/right side Rocker Guard installation.
- **7.** Do periodic inspections to the installation to make sure that all hardware is secure and tight.

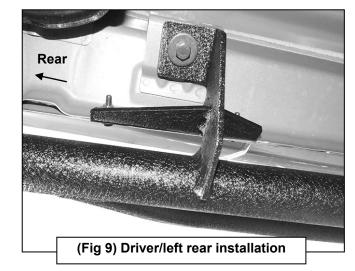
(Fig 8) Driver/left rear installation

8mm x 35mm Hex Bolt 8mm Lock Washer 8mm Flat Washer

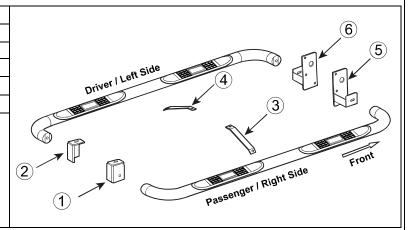
1	Passenger / Right 'Rear' Bracket marked "PR"
2	Driver / Left 'Rear' Bracket marked "DR"
3	Passenger / Right 'Center' Bracket marked "PC"
4	Driver / Left 'Center' Bracket marked "DC"
5	Passenger / Right 'Front' Bracket marked "PF"
6	Driver / Left 'Front' Bracket marked "DF"
