Aggressive Running Board Part No. RBA015TI

Fits: 1999-2016 Ford F250/350/450/550 Superduty Crew Cab

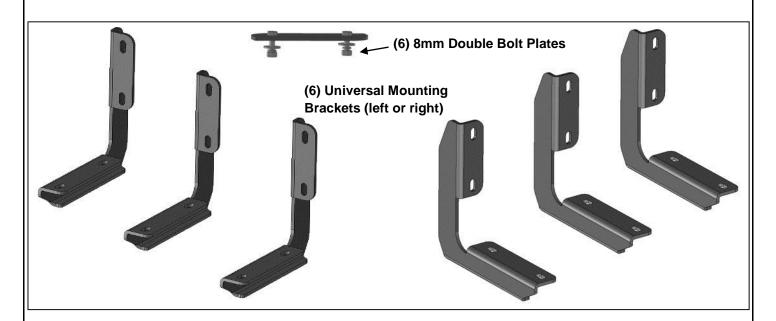
PARTS LIST:				
Qty	Part Description	Qty	Part Description	
2	Aggressive Running Boards	18	8mm Lock Washers	
6	Universal Mounting Brackets (left of right)	12	8-1.25mm Hex Nuts	
6	8-1.25mm Clip-Nuts	6	8-1.25mm Nylon Lock Nuts	
12	8-1.25mm x 25mm Hex Bolts	6	8mm Double Bolt Plates	
30	8mm x 24mm x 2mm Flat Washer

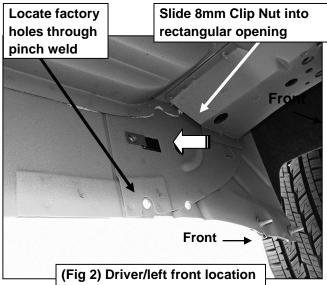
- 1. REMOVE CONTENTS FROM BOX. VERIFY ALL PARTS ARE PRESENT. READ INSTRUCTIONS CAREFULLY BEFORE STARTING INSTALLATION.
- 2. Starting on the front-driver side of the vehicle, locate the (2) holes through the bottom of the body panel, (pinch weld). Next locate the rectangular opening and small hole in the inner body panel directly above the holes in the pinch weld, (Figures 1 & 2). NOTE: The holes in the inner panel may be covered with sealing tape or insulation, remove as required.

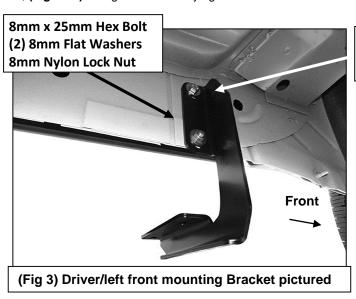
- 3. Slide (1) 8mm Clip Nut into the rectangular opening with the nut towards the inside. Line up the threaded nut on the clip with the round hole toward the rear, (Figure 2).
- 4. Select (1) Mounting Bracket. Attach the top of the Bracket to the Clip Nut with (1) 8mm Hex Bolt, (1) 8mm Lock Washer and (1) 8mm Flat Washer, (Figure 3). Leave loose at this time. Line up the lower hole in the Bracket with the hole through the pinch weld. Attach the Bracket to the pinch weld with (1) 8mm Hex Bolt, (2) 8mm Flat Washers and (1) 8mm Nylon Lock Nut, (Figure 3). Snug but do not fully tighten Bracket hardware.

8mm x 25mm Hex Bolt 8mm Lock Washer 8mm Flat Washer

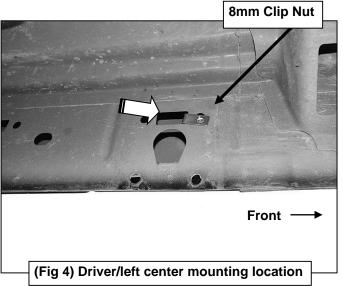
(Fig 5) Driver/left center Bracket pictured

5. Move toward the center of the vehicle. Use **Figure 1** to determine the correct mounting location for the center Bracket. Select (1) 8mm Clip Nut. Repeat **Steps 2 & 3** to install (1) Clip Nut in the correct top mounting hole, **(Figure 4)**. Repeat **Step 4** to attach the Bracket to the Clip Nut and pinch weld, **(Figure 5)**. Snug but do not fully tighten Bracket hardware.

8mm x 25mm Hex Bolt 8mm Lock Washer 8mm Flat Washer

8mm x 25mm Hex Bolt (2) 8mm Flat Washers 8mm Nylon Lock Nut

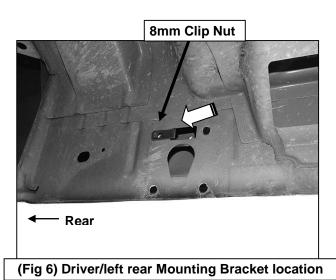
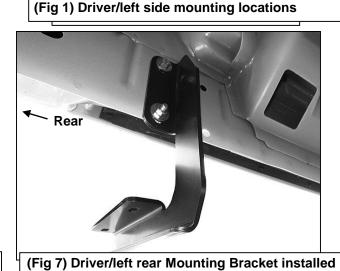
6. Continue along the cab to the rear mounting location. Locate the last (2) mounting holes in the pinch weld towards the back of the cab, (Figures 1 & 6). Use Figure 1 to determine correct mounting location. Repeat Step 5 to install (1) Bracket in the rear location, (Figures 6 & 7).

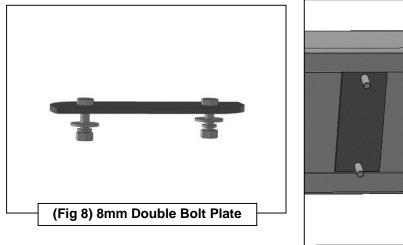
7. Carefully unwrap (1) Running Board. Place the Running Board on top of the Brackets. Locate the channels in the bottom of the Running Board. Select (3) 8mm Double Bolt Plates, (Figure 8). Insert the Bolt Plates into the channels in the bottom of the Running Board closest to the Brackets, (Figure 9). Lift the Running Board up and guide the studs down through the Brackets.

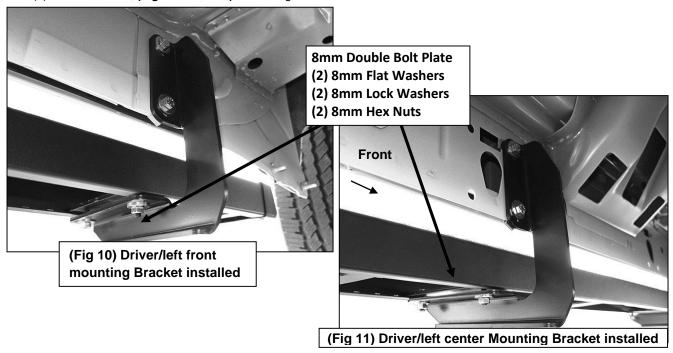
8. Attach the Running Board to the (3) Mounting Brackets with the included (6) 8mm Flat Washers, (6) 8mm Lock Washers and (6) 8mm Hex Nuts, (Figures 10 & 11). Do not tighten hardware at this time.
